# -M54 SIDE MOUNTED LEGS AND -M54-M58 FACEPLATE FOR WATER CLOSET SUPPORTS

## -M54-M58 FACEPLATE WITH ADJUSTABLE NIPPLE AND "O" RING

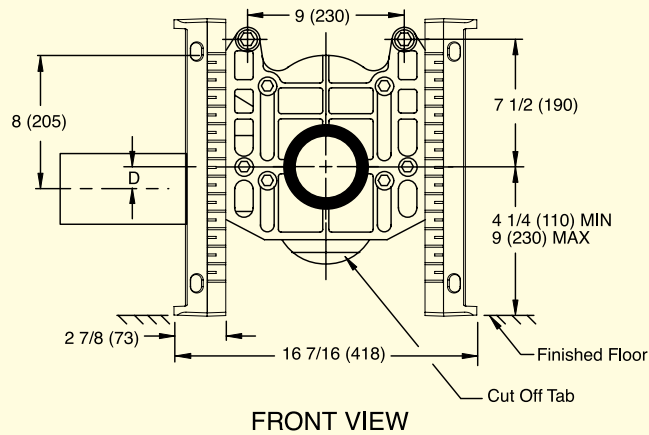
**Fig. # -M54-M58 Faceplate, -M54 Side Mounted Legs, and -M51 Anchor Foot**

- Symmetric construction.
- Increased load bearing capability.
- One bolt per leg allowing quicker and easier prefabrication.
- Incremental markings in 1/2" increments.
- Quicker rough-in for the installing contractor.
- Three Anchor Points for Secure Installation.

- Integral adjustable wall coupling, nipple, and test cap.
- Adjustment at the faceplate rather than at the rear of the water closet (coupling).
- 10 inch-long nipple cover various installations.
- Enhanced sealing with an "O" ring at the faceplate.

- Provides back anchor support for any single horizontal or vertical fixture support.
- Consists of a 3/8" stud and a cast iron anchor foot.
